Death in the line of duty...

A summary of a NIOSH fire fighter fatality investigation

A Career Captain and an Engineer Die While Conducting a Primary Search at a Residential Structure Fire – California

Fatality Assessment and Control Evaluation Investigation Report # F2007-28

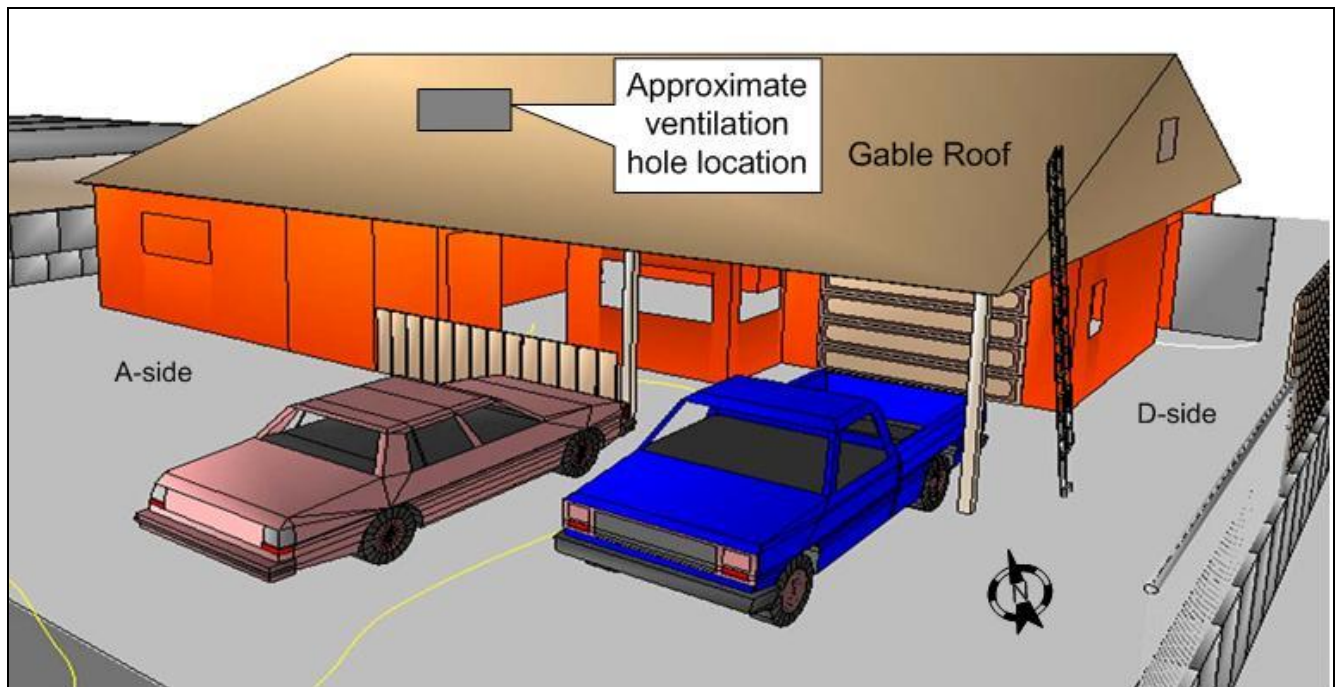
The crew from E69 laddered the D-side towards the front of the structure and then heard that the first civilian was found and was being removed from the structure (Figure 1). The E69 crew immediately went to the front porch to assist with removing the civilian to the front lawn area. *Note: The gas powered PPV fan was running facing the front door. The E69 officer noticed that the smoke conditions in the living room area were negligible at this time.*

Figure 1. Ladder location on D-Side of structure.

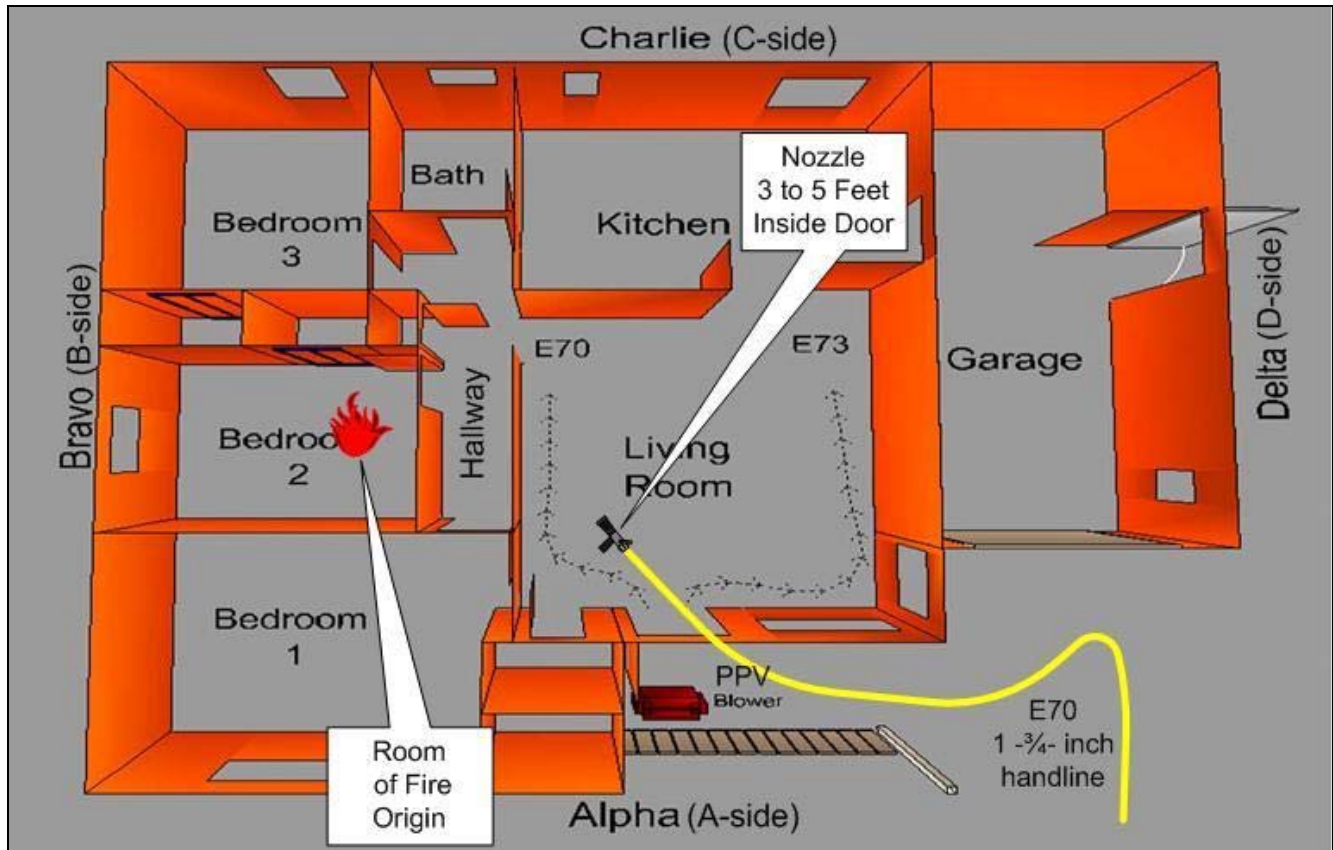
The fire originated in the Bedroom 2 (see Figure 2) where the two victims were found. It is believed to have started from improper disposal of smoking materials by the owners.

to confirm his request with Engine 69 (E69) while they were responding. The fire fighter from E73 went to retrieve the TIC. The E70 engineer told him that he would get it and directed him to help with hooking-up the hydrant. After assisting with the hydrant, the E73 fire fighter returned to make entry. The officer from E73 requested a positive pressure ventilation (PPV) fan from Engine 70 because visibility was zero. The two victims were standing as they made entry through the smoke and proceeded to the left. The crew from E73 went to the right to search for the victims. The conditions were hot and visibility was near zero. (Figure 2).

In this incident, positive pressure was applied at the door on Side-A with the only exhaust opening being the large window in the living room which had broken out prior to the arrival of the first company. This potentially placed the search teams between the fire (in the bedrooms and hallway) and the exhaust opening (in the living room). In addition, no fire control action was being taken during the search as the hoseline deployed by E70 was unstaffed. Application of positive pressure without an adequate opening (in this case the opening may have been marginally adequate, but in a non optimal location) results in increased air supply to the fire, turbulence, and mixing of hot smoke (fuel) and air which can result in a fire gas ignition or ventilation induced flashover. It is not recommended to initiate positive pressure ventilation after firefighters enter the building⁸. If used post fire control, fire fighters should be withdrawn to a safe (uninvolved) area or out of the building while it is pressurized. If used in positive pressure attack, the building should be pressurized and the effectiveness of ventilation verified by observation prior to entry⁸.

Figure 2. Location of E70 nozzle, positive pressure ventilation, and search patterns of E70 and E73.

Recommendation #4: Ensure that firefighters understand the influence of positive pressure ventilation on fire behavior and can effectively apply ventilation tactics.

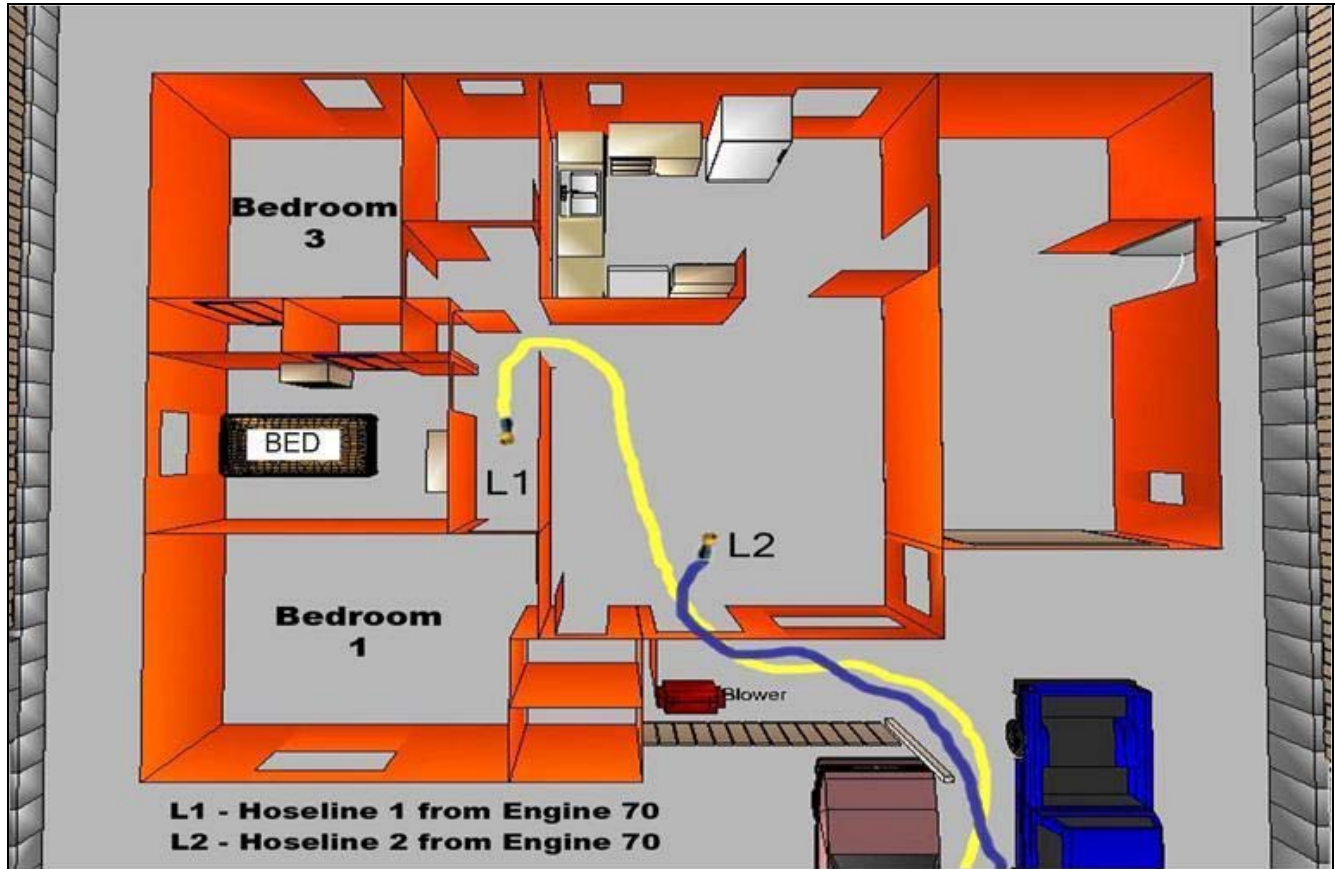
The Q76 officer was backing up his fire fighter on the nozzle as they fought fire around the corner and into the hallway leading into the bedrooms (Figure 3). They darkened down the fire in the middle bedroom and the captain scanned the area with his TIC and did not pick up anything on the screen. *Note: The crew from Q76 did not know that the victims were missing at this point. The crew did not hear any PASS devices.*

Figure 3. Hoseline locations from E70.

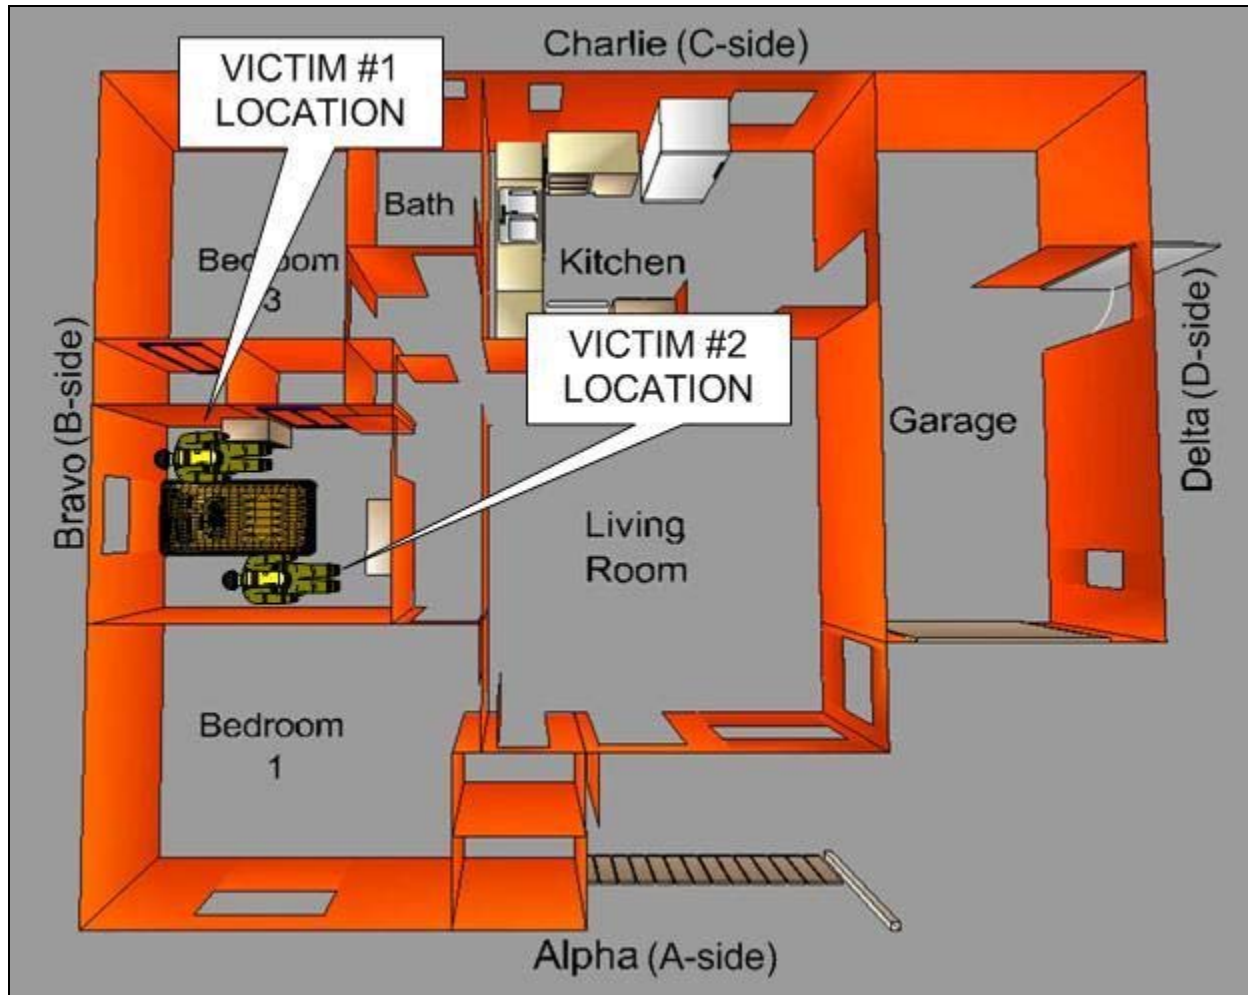
The E69 crew re-entered with a handline, but did not have a TIC with them. They proceeded into the hallway and bedroom areas and extinguished spot fires as they searched for the missing fire fighters and listened for any PASS devices. *Note: It is probable that the PASS devices did not function properly due to the heat and fire impingement.* The smoke was banked down to around neck level with good visibility below that level. The crew visibly searched the small bedrooms, but did not see the victims. The E69 officer exited to confirm his finding with the IC and to make sure the E70 crew was not outside. He went back inside and met-up with his crew in Bedroom #2. The crew was searching when the evacuation horns sounded at approximately 0221 hours. BC7 ordered the evacuation signal to conduct a personnel accountability report (PAR). They began to exit when the E69 engineer noticed Victim #1 in the right rear corner of Bedroom #2. They immediately began to remove Victim #1. FF76 and E68 crew assisted with the removal. BC 64 was on-the-scene at this time and was aware of a fire fighter missing, but not fully aware of the search operations taking place. He entered without proper turnout gear in an attempt to search for the second victim. Victim #2 was located on the left side of Bedroom #2 by the Q76 officer. Additional crews, including an automatic aid crew and BC64 assisted with recovering the victim from the structure at approximately 0228 hours (Figure #4).

Figure 4. Location of victims in Bedroom #2.

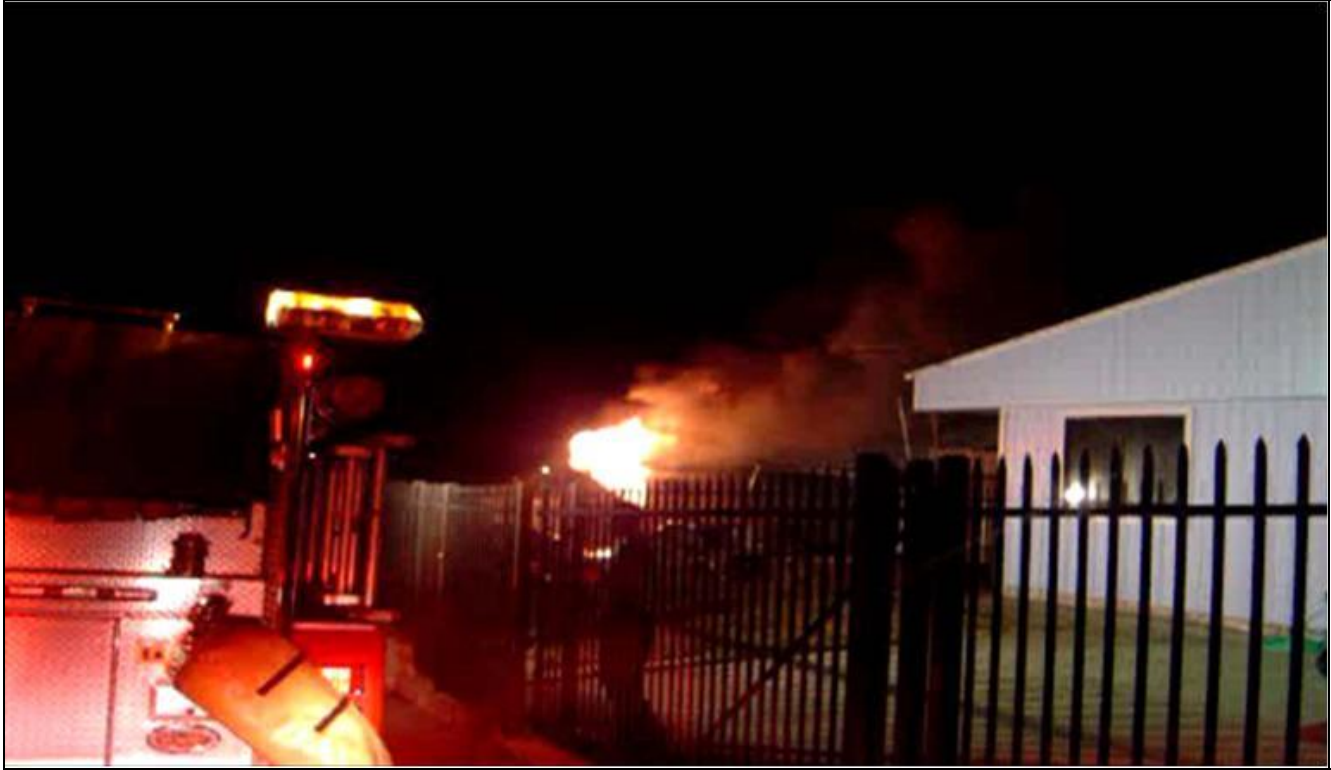
Quint 76 (Q76) arrived on-the-scene at 0159 hours. While the crew was donning their gear, the Q76 fire fighter took a photograph and a short video that showed a rapid fire event venting from the A-side bedroom window (Photo 1). The E73 fire fighter was administering care to the civilian on the front lawn when the rapid fire event occurred and he reported large amounts of fire venting from the front bedroom window for approximately 15 seconds. *Note: Members on the fire ground described the rapid fire progression as a sound resembling a tire exploding, which resulted in heavy flames shooting out from the front bedroom window.*

Photo 1. Flames exiting window on A-Side from rapid fire development.
(Photo courtesy of Fire Department.)
